Analysis of the deadly Fort Worth, Texas pileup of February 11, 2021: Its cause, contributing factors and future prevention

DALLAS-FORT WORTH, TX - At about 6am on Thursday, February 11, 2021, a pileup involving 133 vehicles occurred on Interstate 35 West 2 miles north of downtown Fort Worth, Texas. 6 people lost their lives and at least 60 were injured, with 36 requiring transport to a hospital. This article will examine the cause of this tragedy and offer a potential solution to prevent similar incidents in the future. *Please note that this is an independently-produced analysis, and it is not affiliated in any way with the NTSB or any government agency.*

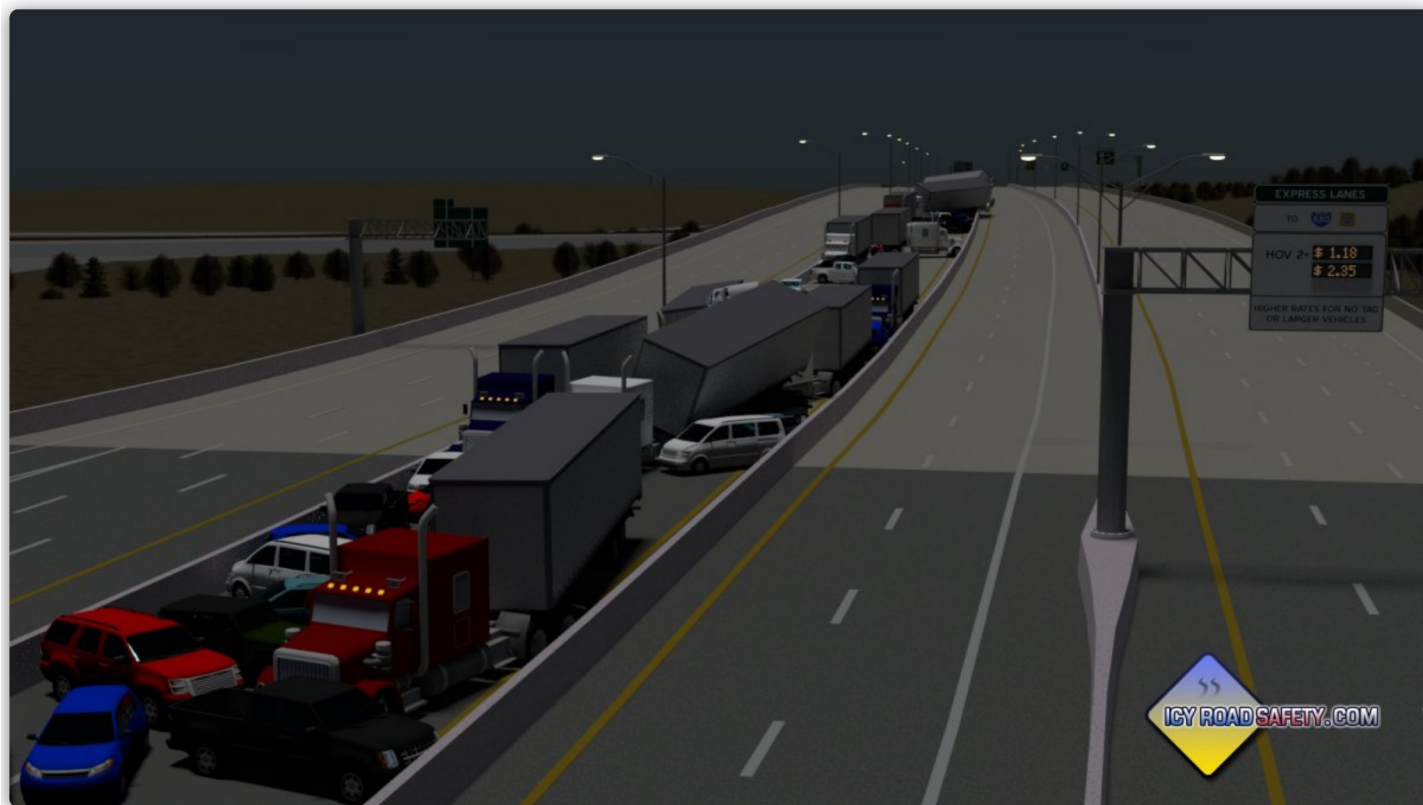
I-35W Fort Worth pileup overview, 3D rendering. Vehicle types and positions are only approximations. Looking north from the bridge's south end

The Fort Worth pileup, in all reality, requires no in-depth investigation. Simply put, this event was a result of **freezing rain bridge icing**. There are some factors that contributed to the severity of this incident, which I'll be covering in this article - but the primary cause of the pileup is this well-known phenomenon that routinely causes thousands of serious and fatal crashes every winter.

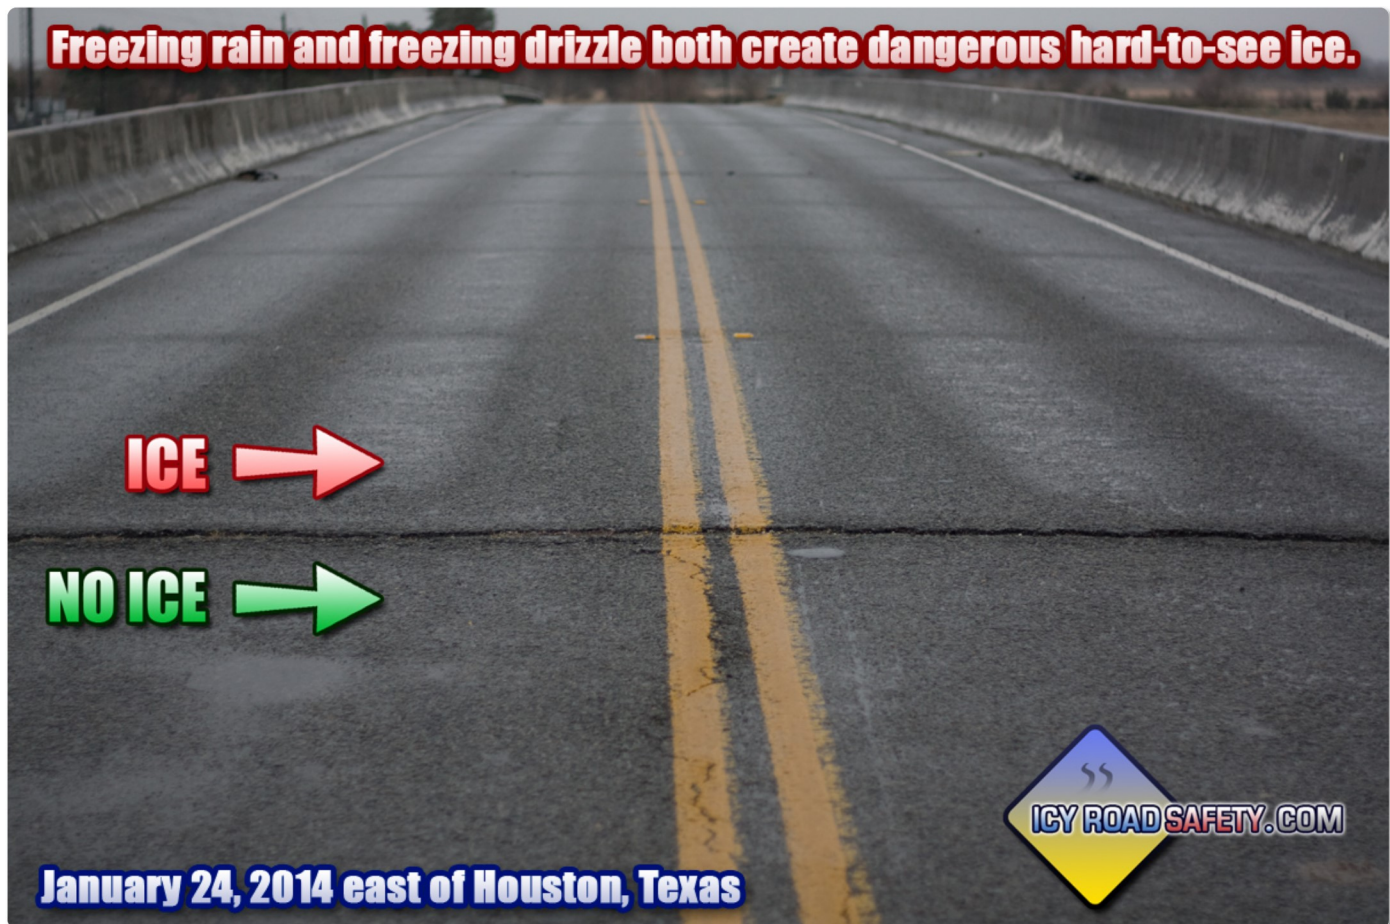
Now let's add in the factor of **freezing rain**. Freezing rain and its close relative freezing drizzle - not only create the slickest road conditions of any winter precipitation type, but the icing is nearly impossible to see. These photos show several examples of bridges iced from freezing rain. Can you see the ice?

Fig 3g: Freezing rain icing on bridge near Winnie, Texas

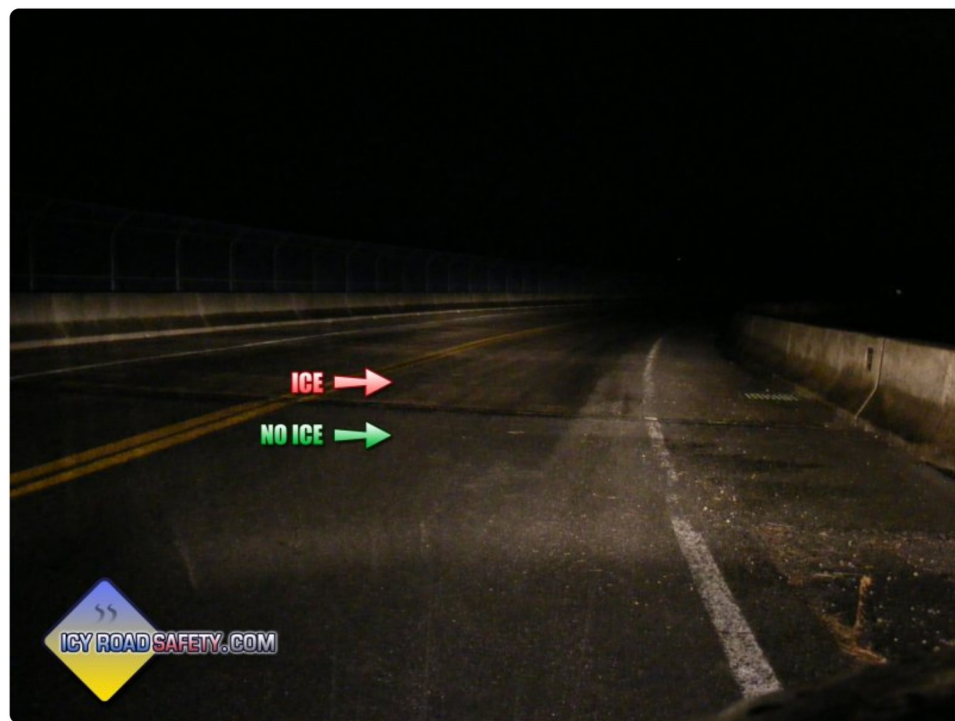
This nighttime image of a freezing rain-iced bridge represents how bridge icing looked on the night of February 10 and morning of February 11, 2021 in the Dallas-Fort Worth metroplex:

Fig 3h: Freezing rain icing on bridge near Beckley, West Virginia

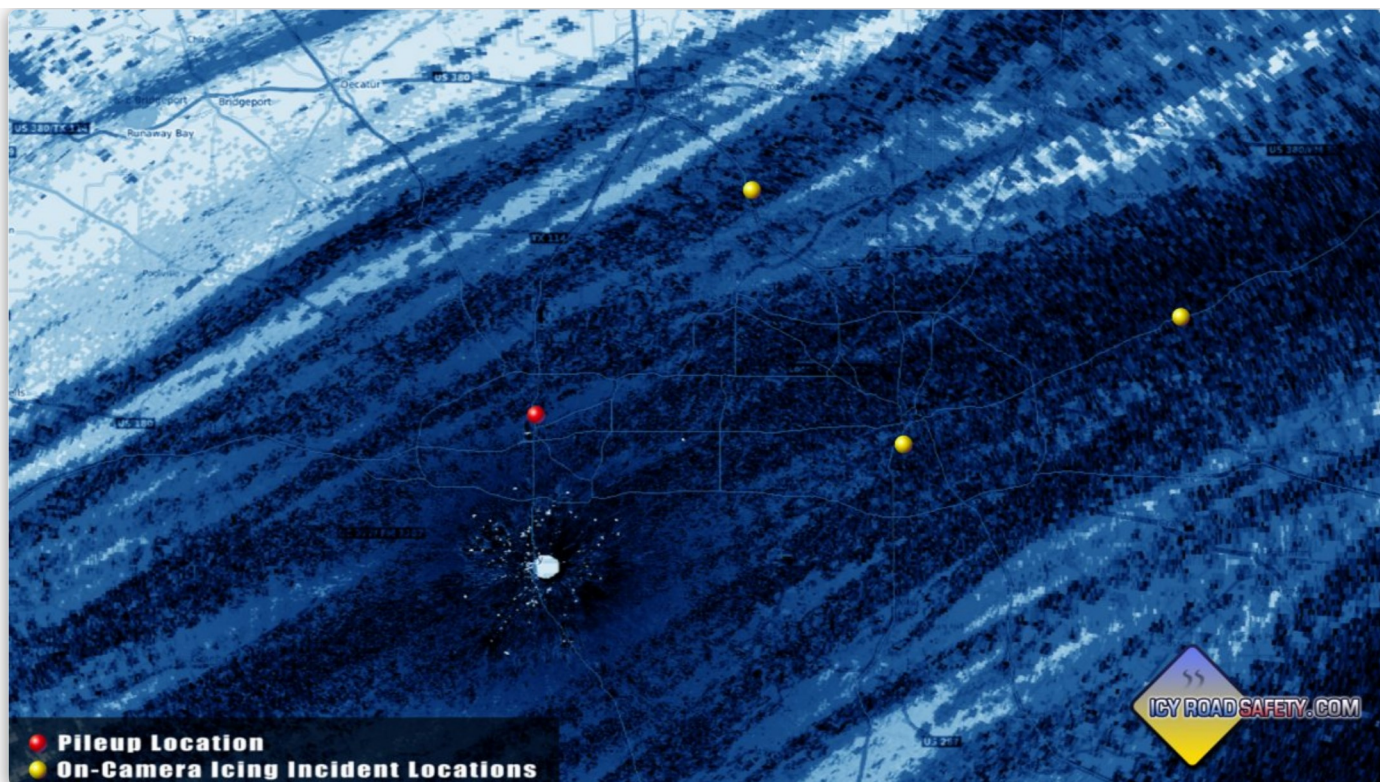
Another visualization of the freezing rain precipitation swaths can be produced by stacking monochrome versions of the radar images together using Photoshop. This image shows these swaths during the 7-hour period from 11PM and 6AM. Darker blues indicate heavier precipitation amounts:

Fig 4b: Radar-derived precipitation swaths between 0500Z and 1200Z Thursday, February 11, 2021

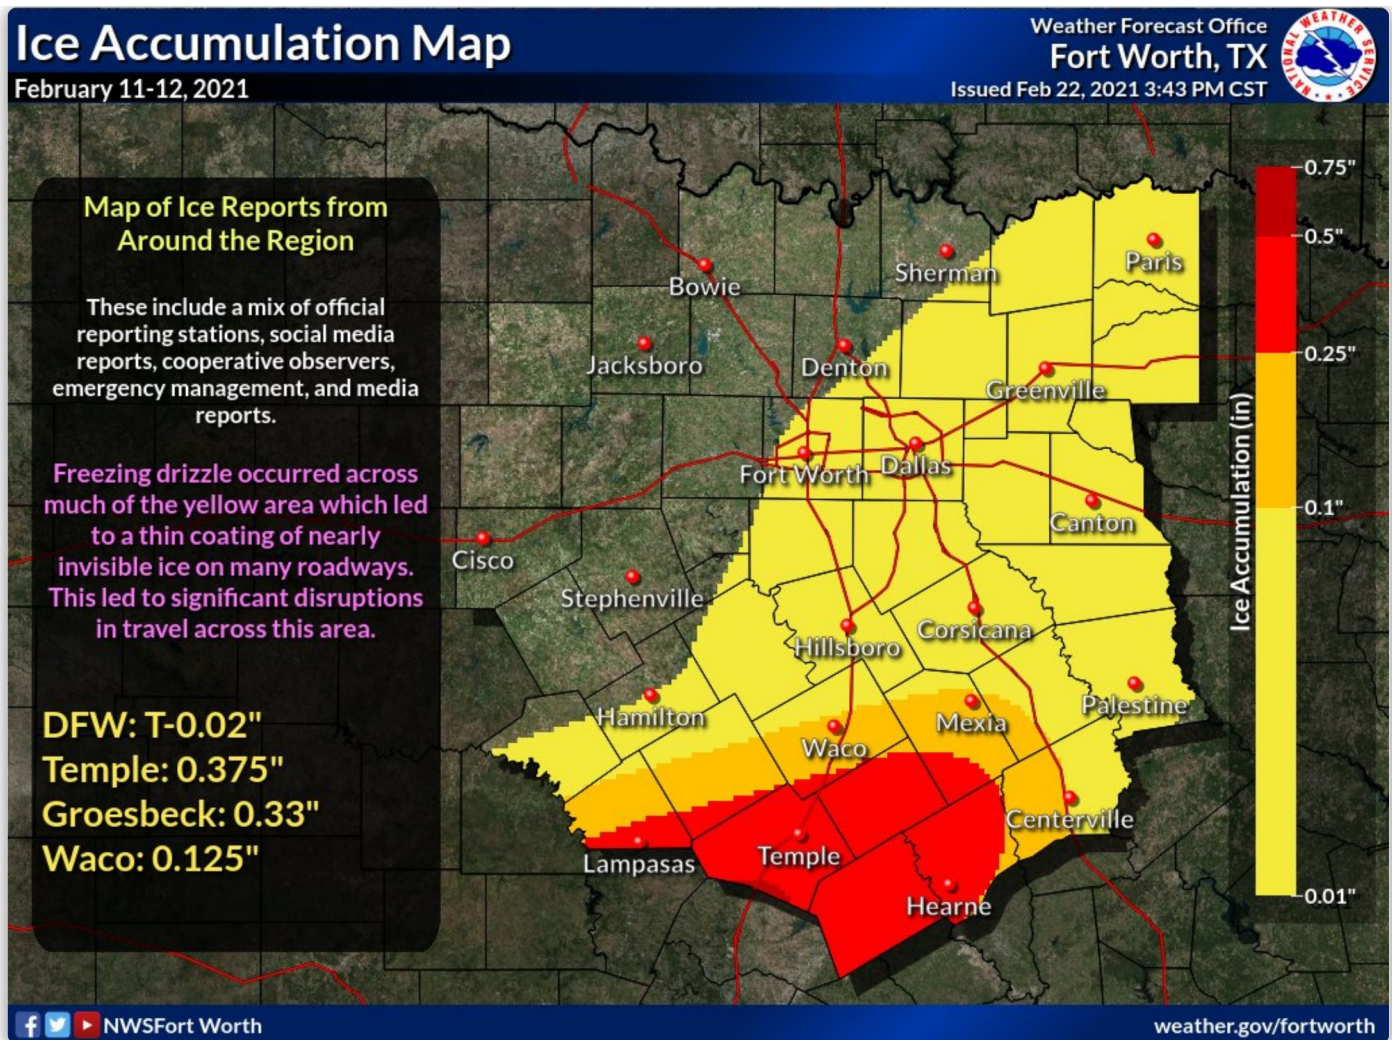
The Fort Worth NWS published this map of icing totals from the event, noting that precipitation amounts were less than 2 hundredths of an inch across the metroplex:

Fig 4c: NWS ice accumulation totals

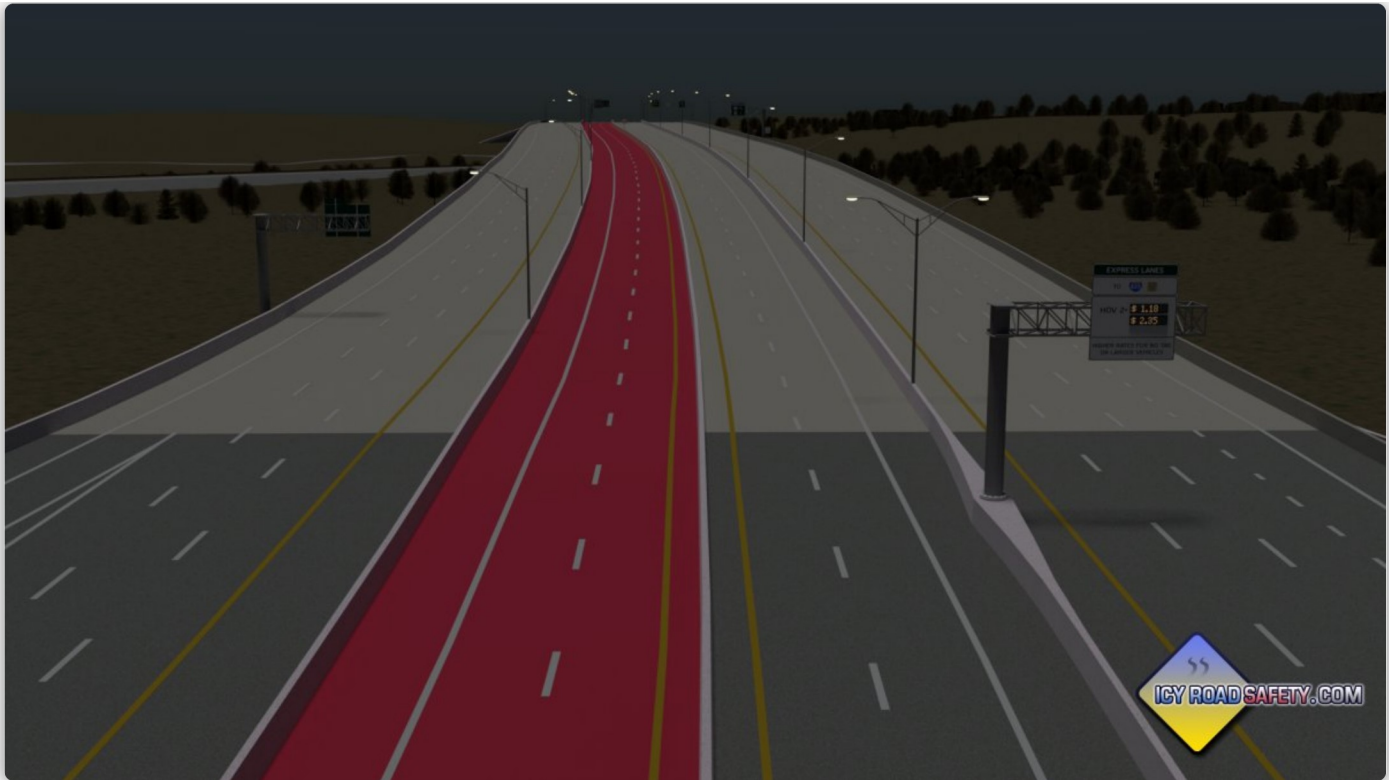
The express lanes are in the center of the bridge, bounded by concrete barriers. The pileup occurred in the southbound express lanes, highlighted here in red, and mainly at and just beyond the southern end of the bridge.

Fig 5d: I-35W southbound express lanes where the pileup occurred

Obviously, this bridge will ice during freezing rain the same way that any bridge will. Other bridges in the metroplex were icing rapidly during any freezing rain shower that moved overhead, and this one would have been no different. Bystander videos of the Fort Worth pileup showed vehicles in the northbound mainline lanes spinning their wheels (3) and disabled wrecked vehicles in the southbound mainline lanes (4), evidence that indicates the entire bridge was iced, not just the express lanes. I can't comment on details of the deicing operations in the metroplex other to say that I did see brine trucks applying the liquid solution to areas that had already begun icing in Rockwall. Based on my experience observing winter weather events, deicing chemicals are often quickly washed away during freezing rain and require repeated applications to remain effective.

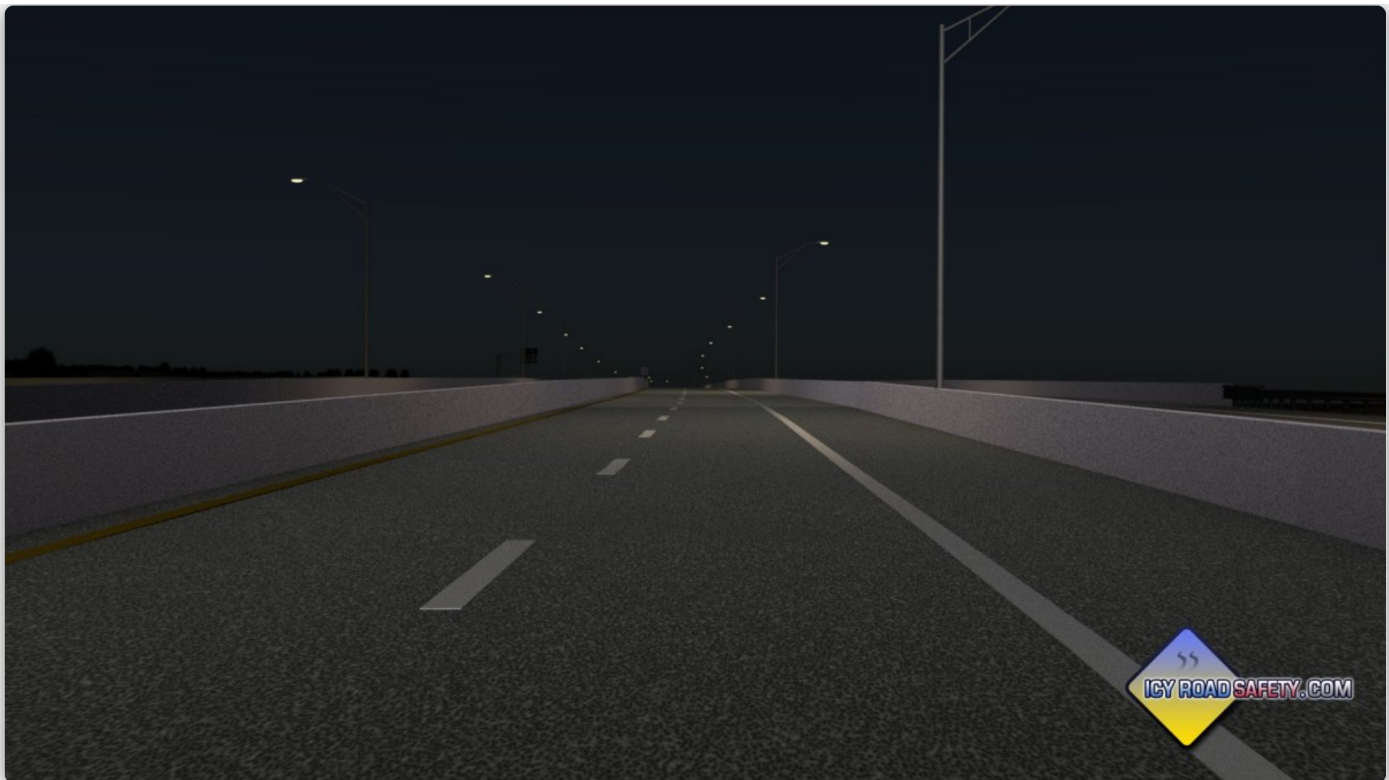
Let's take a look at what a driver would have seen approaching the pileup in the southbound express lanes. Just prior to the bridge, the highway gains elevation before cresting at the bridge's northern end, which would result in the southern end of the bridge being invisible to approaching southbound drivers.

Fig 5e: 3D rendering of I-35W southbound express lanes driver view just before bridge

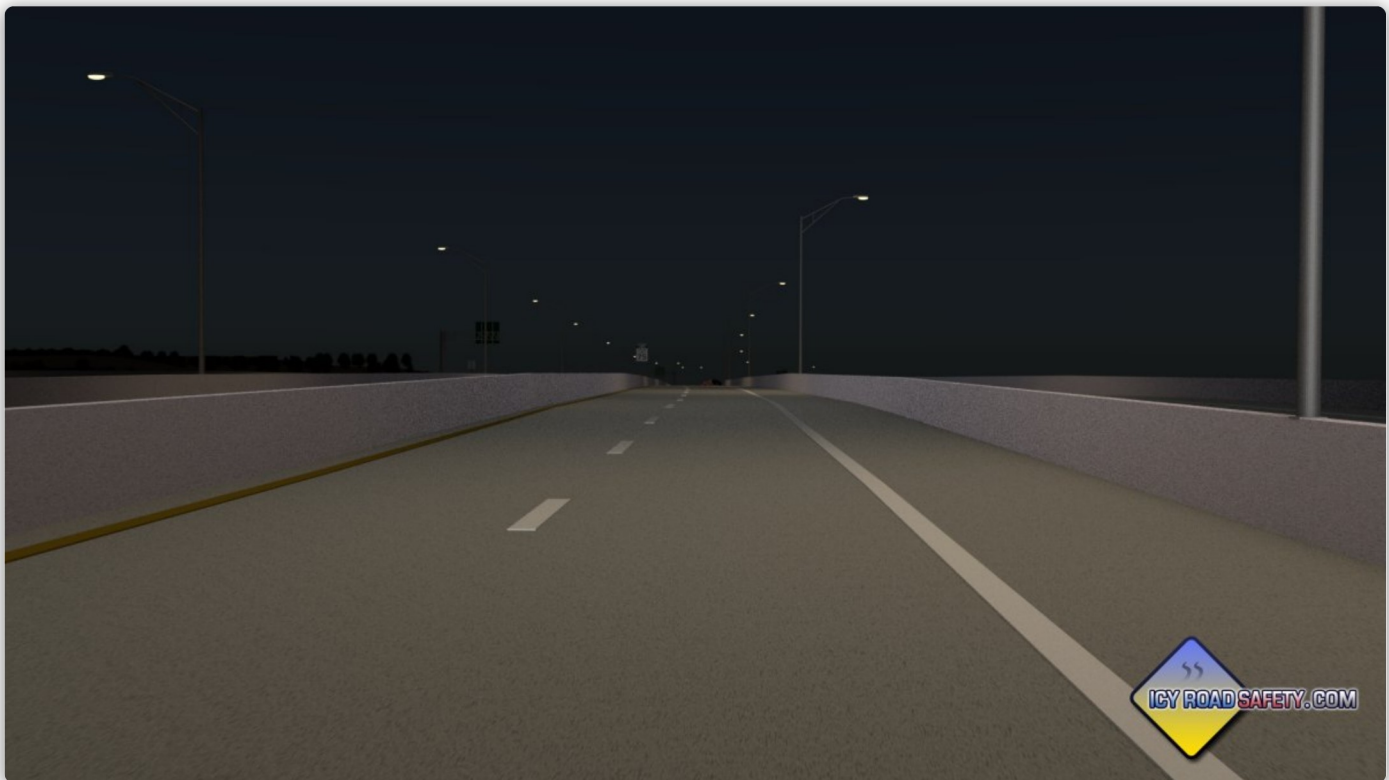
The disabled vehicles already involved in the pileup would not appear to the southbound driver until they were squarely on the downhill section of the treacherously-iced bridge:

Fig 5f: 3D rendering of I-35W southbound express lanes driver view, first view of pileup vehicles

At that point, braking would have little effect, especially at the speeds vehicles were traveling. Again, freezing rain icing is often impossible to visually identify, so most drivers involved in the pileup likely were not aware they were on ice until they attempted to brake on the bridge.

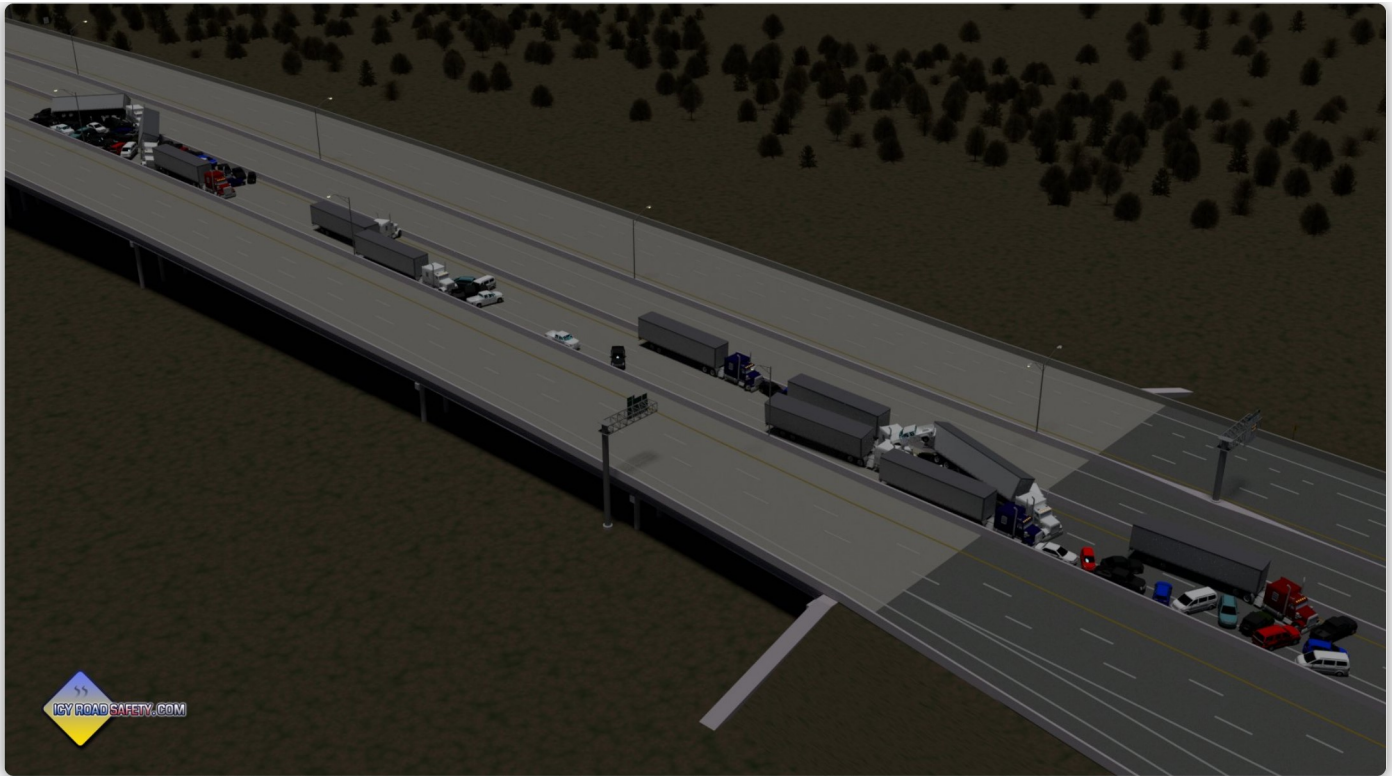
Aftermath images show that the pileup occurred in three distinct clusters on the bridge, with the most vehicles concentrated in the southernmost and northernmost clusters:

Fig 5g: I-35W Fort Worth pileup overview, 3D rendering. View looking northeast. Vehicle types and positions are only approximations.

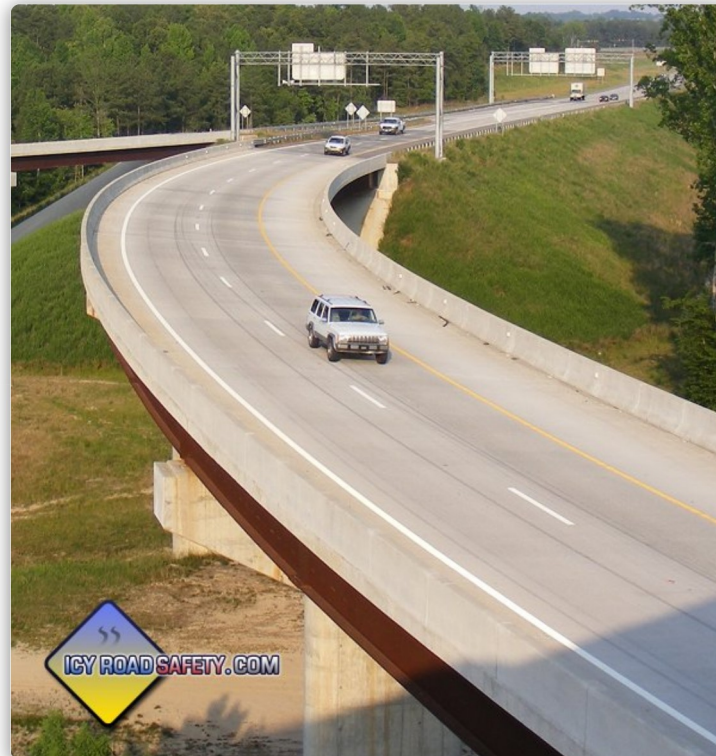
Barrier confinement: While it is true that the express lanes of I-35W are bounded by concrete barriers that make evasive action by approaching drivers difficult (or impossible), this is not a unique configuration. Travel lanes on *all* highway bridges are bounded by such barriers, so their presence in this case is not remarkable. As such, they should not be cited as a contributing factor to this incident. Barriers are simply an inherent characteristic of bridges, and cannot be eliminated or reduced.

Fig 5h: Confining barriers are an inherent characteristic of every highway bridge.

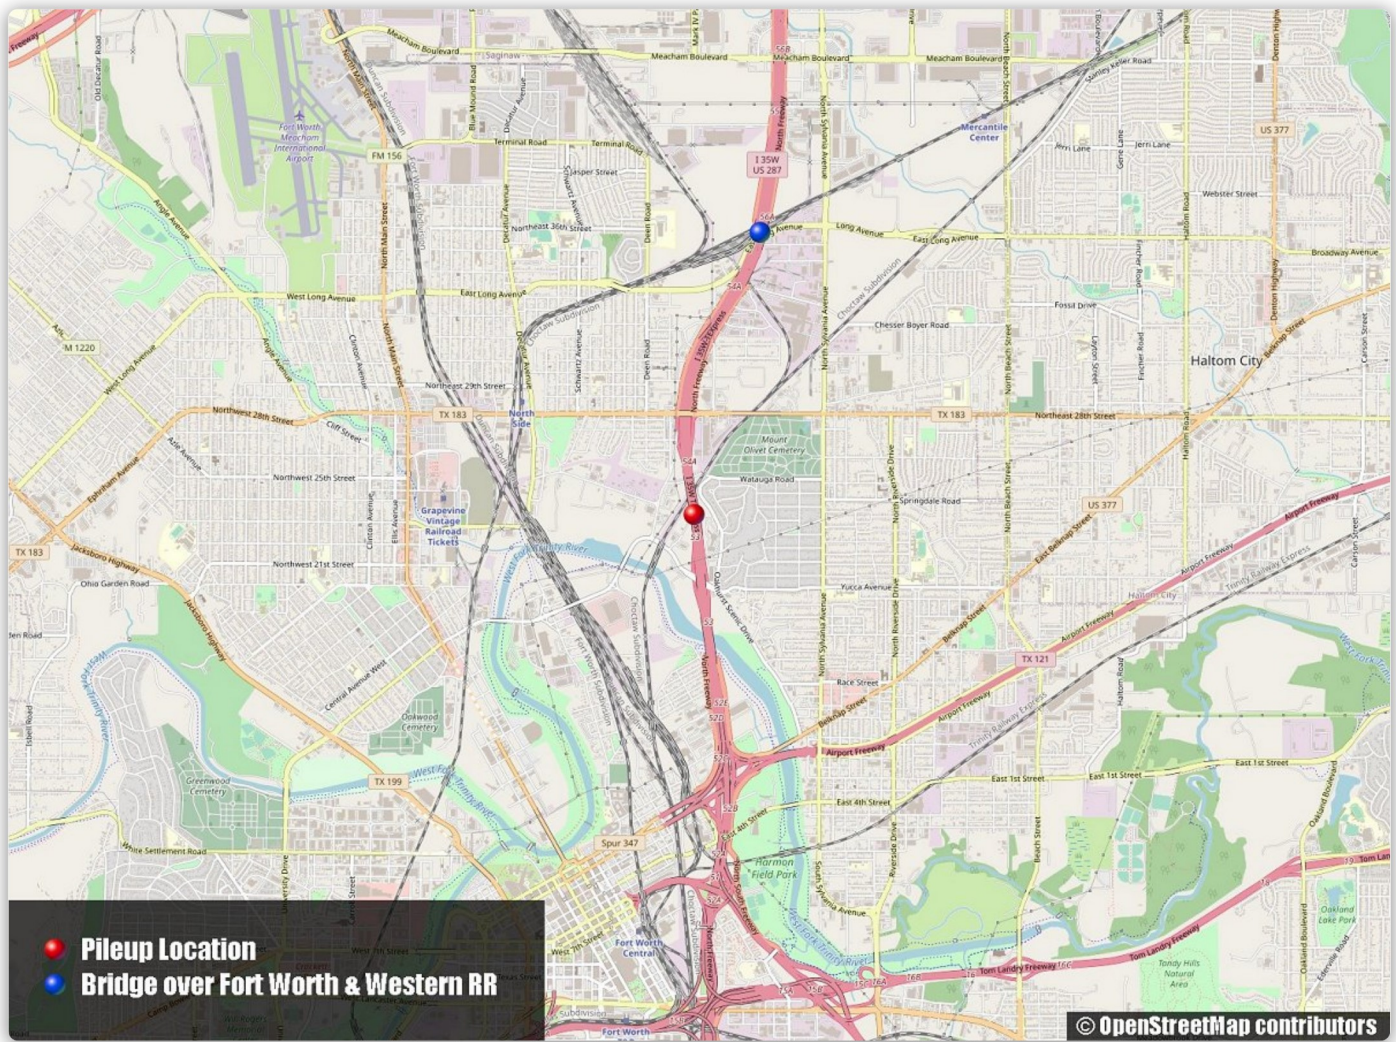
Preceding bridges: Southbound express lane vehicles would have crossed over a bridge of similar length approximately one and 1/4 miles before encountering the pileup bridge. This bridge over the Fort Worth and Western railroad yard gently curves to the left, a configuration that can induce "oversteer" loss of control on ice when drivers must steer on the curve. The condition of this bridge at the time of the pileup is unknown. The radar loop (shown above) indicates that multiple

freezing rain showers did pass over this bridge's location prior to the pileup.

Fig 5i: Locations of pileup bridge and preceding bridge on I-35W (OpenStreetMap)
